Selecting Coatings for Bridge Maintenance

W Deacon, The Steel Protection Consultancy, UK

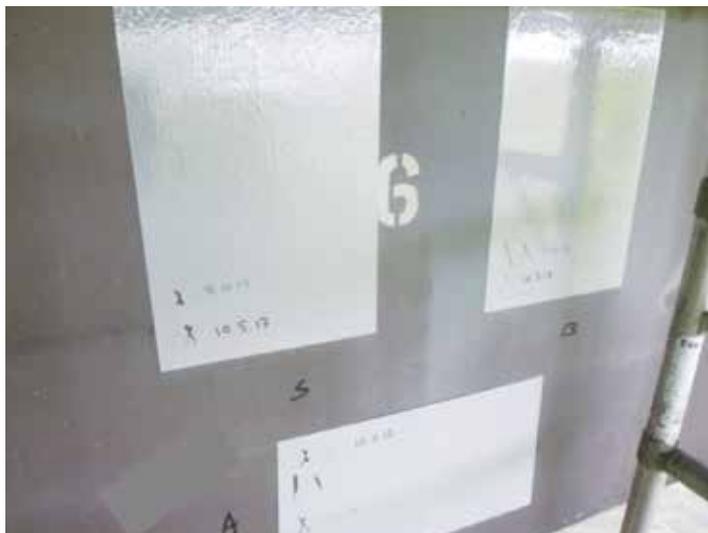
Figure 1: Typical trial patch layout [S=Sweep B=Blast A=Abrade].

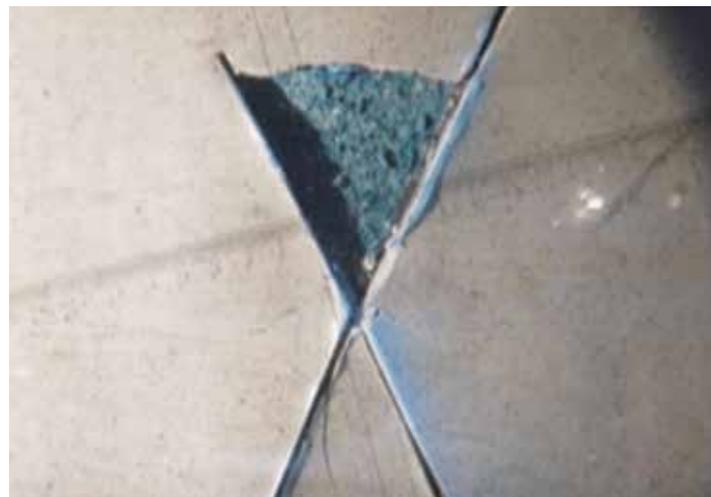
Figure 3(b): Abraded and overcoated with PM 1 system emphasising the cohesive weakness within original.

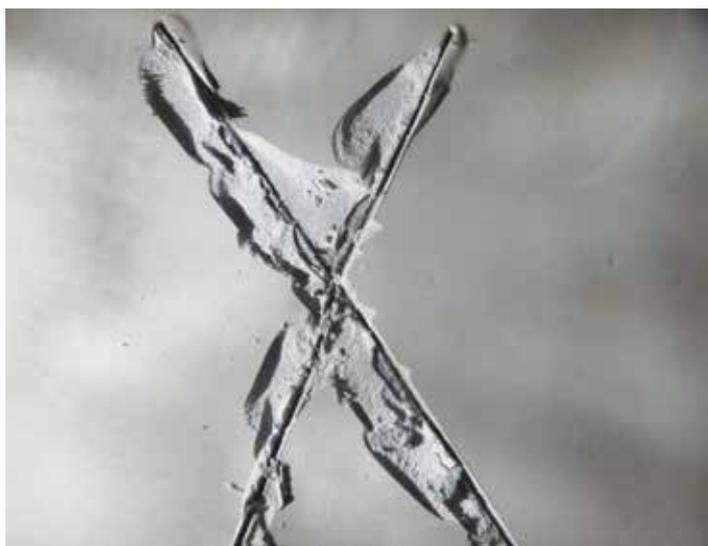
Figure 2: Embrittlement of paint system applied to Sa2½ after 24 months service.

At 18 and 24 months was when significant differences were identified after micro-destructive examination. It became clear that one of the manufacturers systems had now fully cured and had become slightly brittle in a number of instances, both on overcoated and bare steel applications. Another of the manufacturers' products remained similar to the 12 month trial with generally good adhesion to the bare steel but some detachment where the chlorinated rubber and alkyd paints had been overcoated. In some cases, it appeared that the properties within the original coatings had improved with the inherent weaknesses reduced slightly, some had no impact and others had emphasised the weaknesses.

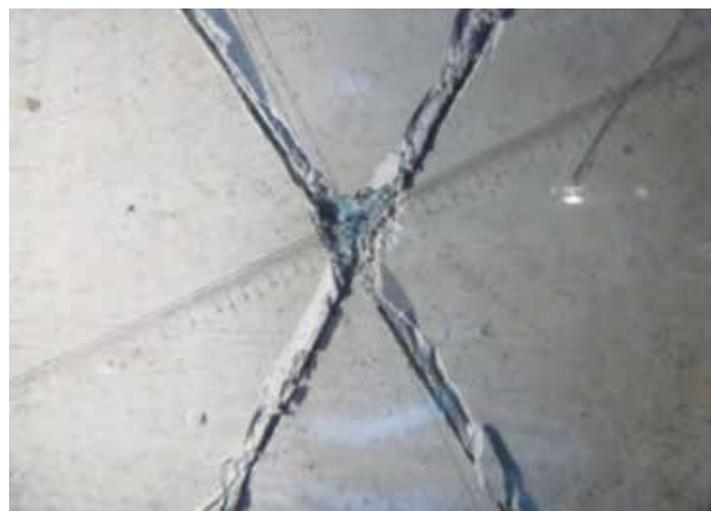
Figure 3(c): Abraded and overcoated with PM 3 system with significant reduction in the cohesive weakness within original.

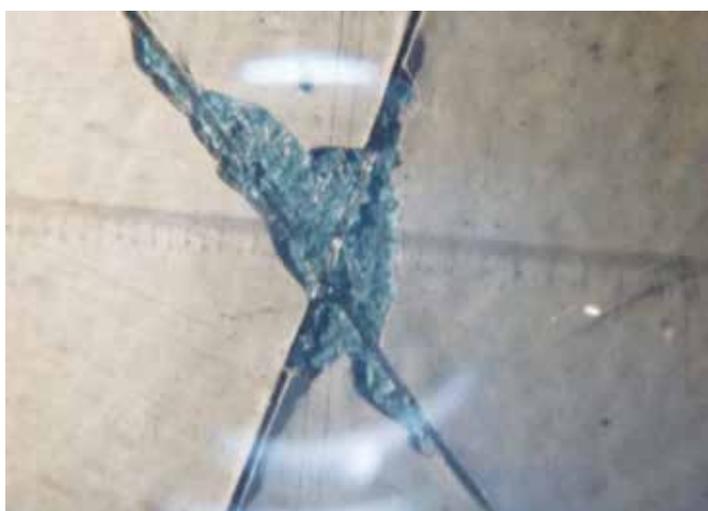
Figure 3(a): Original system with cohesive weakness.

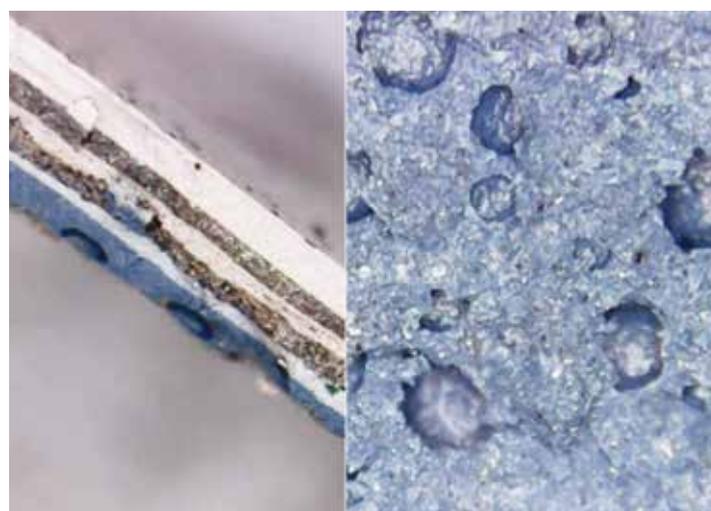
400X magnification. This found very little variance across the trialled topcoats but in cross section some differences were noted such as vacuoles within one manufacturers intermediate build coats and although relatively small could potentially impact the overall permeability of the full coating system.

Figure 4: Vacuoles within original coating where cohesive weakness was identified {Cross section and plan views}.

Figure 4 is an example of the vacuoles seen in the existing coating.
